## PRELIMINARY REPORT

### HIGHWAY

### HWY18MH010

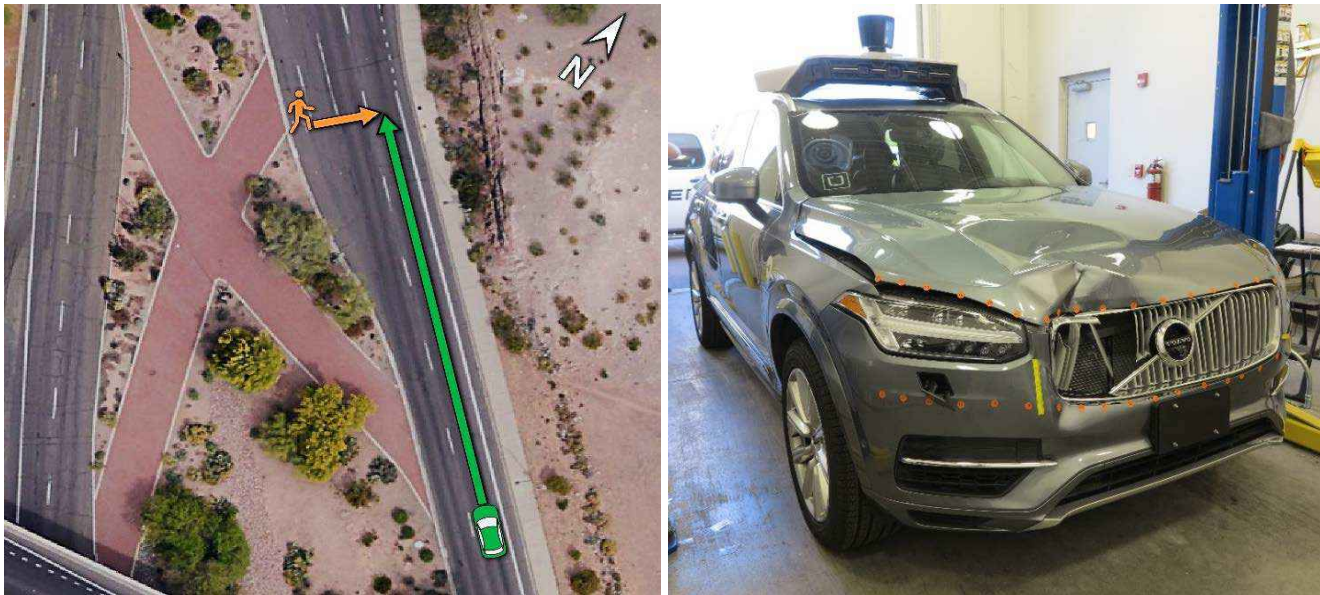
The crash occurred as the pedestrian, a 49-year-old female, walked a bicycle east across Mill Avenue. The Uber test vehicle was traveling in the right through lane when its right front side struck the pedestrian (see figure 1). As a result of the crash, the pedestrian died. The vehicle operator was not injured.

**Figure 1.** (Left) Location of the crash on northbound Mill Avenue, showing the paths of the pedestrian in orange and of the Uber test vehicle in green. (Right) Postcrash view of the Uber test vehicle, showing damage to the right front side.

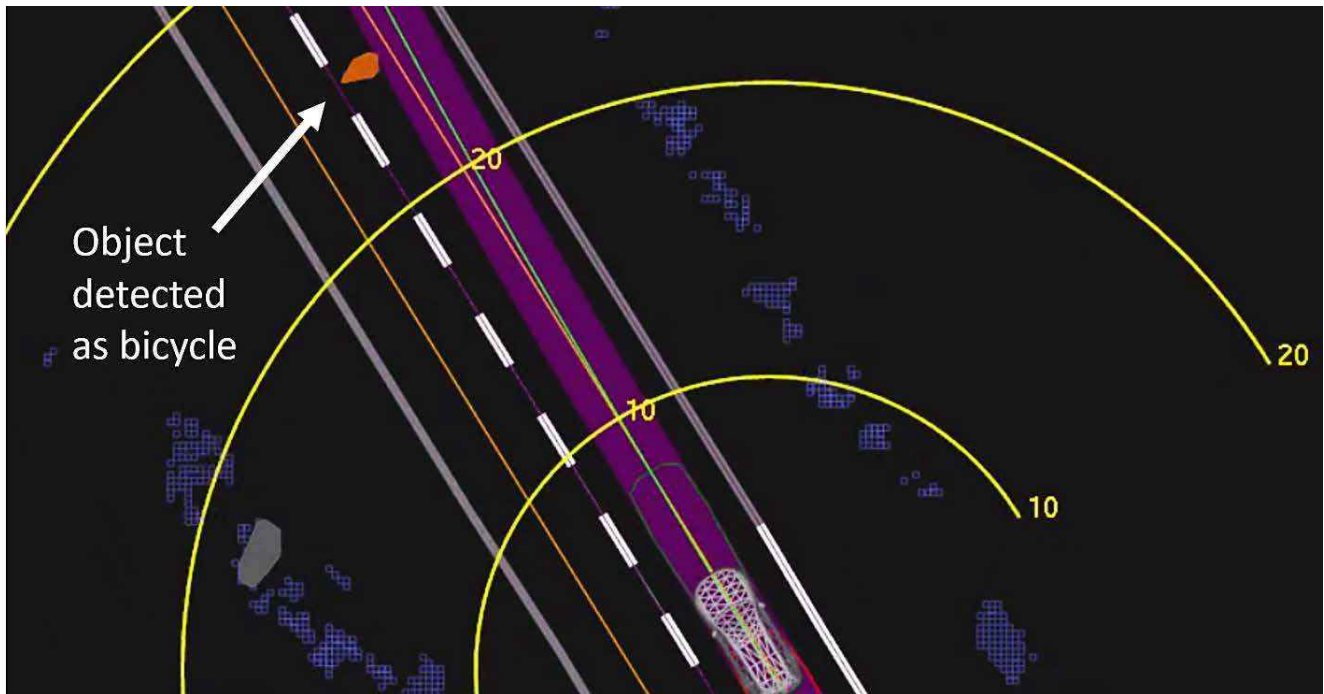
According to data obtained from the self-driving system, the system first registered radar and LIDAR observations of the pedestrian about 6 seconds before impact, when the vehicle was traveling at 43 mph. As the vehicle and pedestrian paths converged, the self-driving system software classified the pedestrian as an unknown object, as a vehicle, and then as a bicycle with varying expectations of future travel path. At 1.3 seconds before impact, the self-driving system determined that an emergency braking maneuver was needed to mitigate a collision (see figure 2).<sup>2</sup> According to Uber, emergency braking maneuvers are not enabled while the vehicle is under computer control, to reduce the potential for erratic vehicle behavior. The vehicle operator is relied on to intervene and take action. The system is not designed to alert the operator.

**Figure 2.** View of the self-driving system data playback at about 1.3 seconds before impact, when the system determined an emergency braking maneuver would be needed to mitigate a collision. Yellow bands are shown in meters ahead. Orange lines show the center of mapped travel lanes. The purple shaded area shows the path the vehicle traveled, with the green line showing the center of that path.
